PRINCE GEORGE'S COUNTY DEPARTMENT OF PARKS AND RECREATION

Drainage Solutions

Institute of Applied Agriculture | University of Maryland

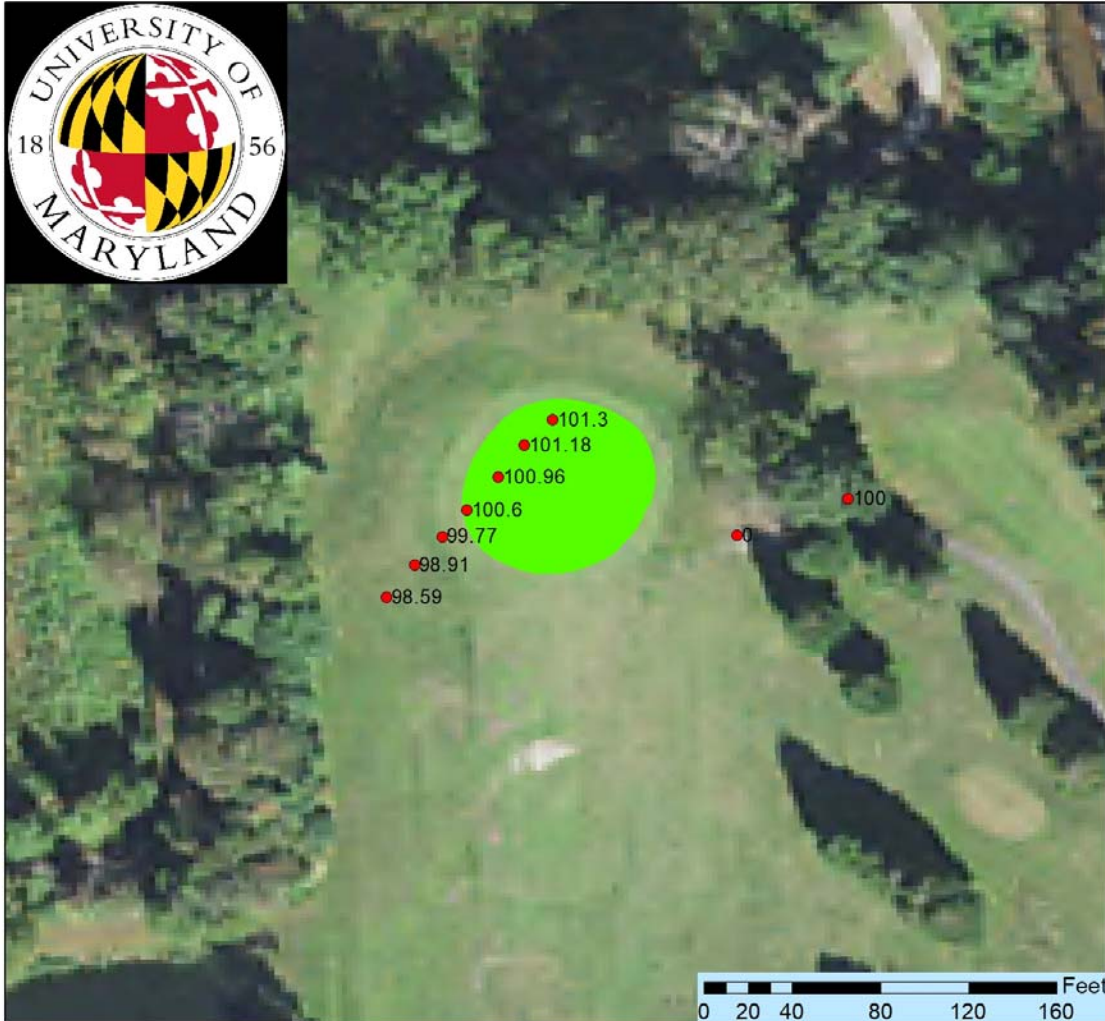
Paint Branch: Number 3 Green

Paint Branch Hole 3 Elevation and Slope				
1	2	3	4	5
				Elev
STA	BS	HI	FS	Profile
BM	3.28			100.00
		103.28		
0+00			1.98	101.30
0+18			2.10	101.18
0+36			2.32	100.96
0+54			2.68	100.60
0+72			3.51	99.77
0+90			4.37	98.91
1+08			4.69	98.59
BM			3.28	
Existing Slope		0.0251	3%

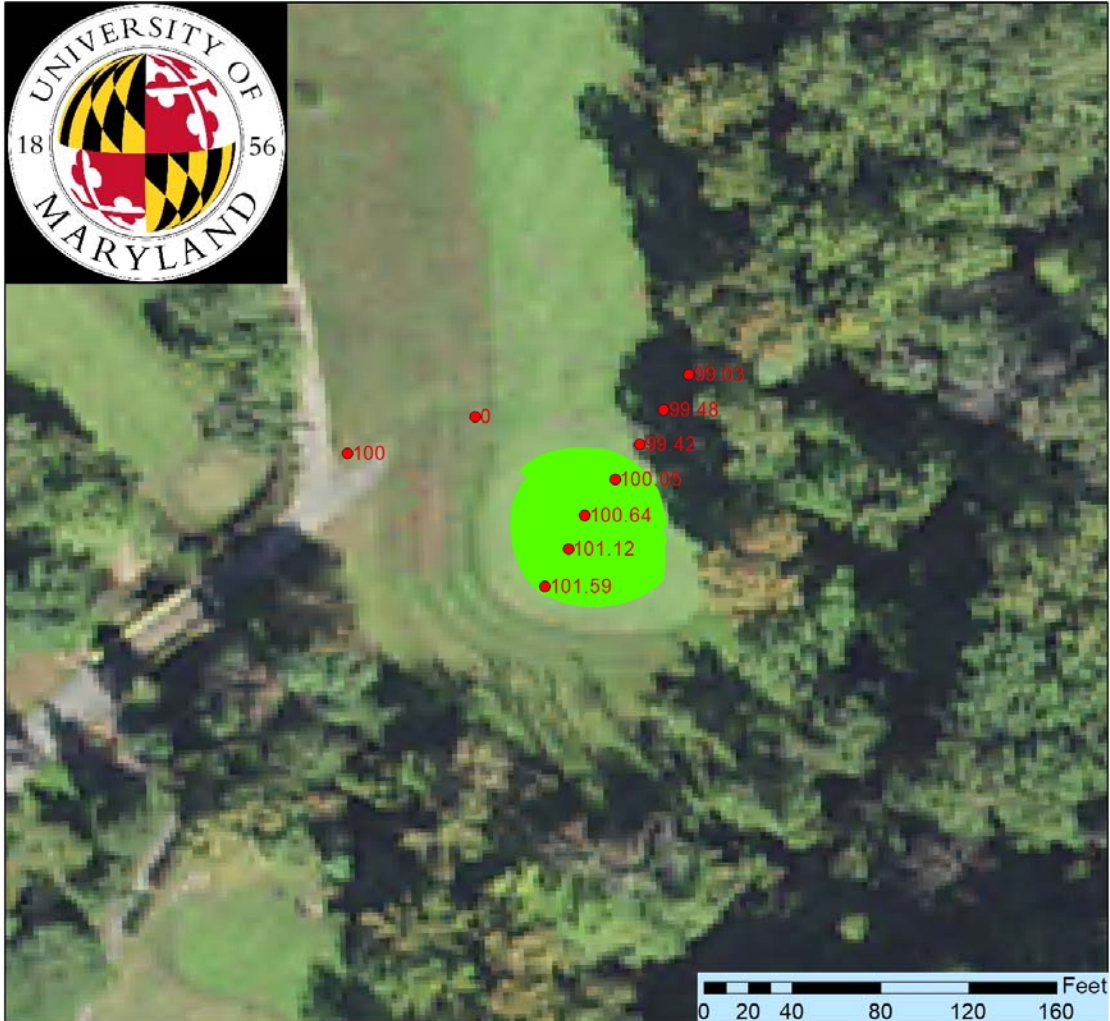
Paint Branch: Number 6 Green

Paint Branch Hole 6 Elevation and Slope				
1	2	3	4	5
				Elev
STA	BS	HI	FS	Profile
BM	4.43			100.00
		104.43		
0+00			2.84	101.59
0+18			3.31	101.12
0+36			3.79	100.64
0+54			4.38	100.05
0+72			5.01	99.42
0+90			4.95	99.48
1+08			5.40	99.03
BM			4.43	
Existing Slope		0.023704	2%

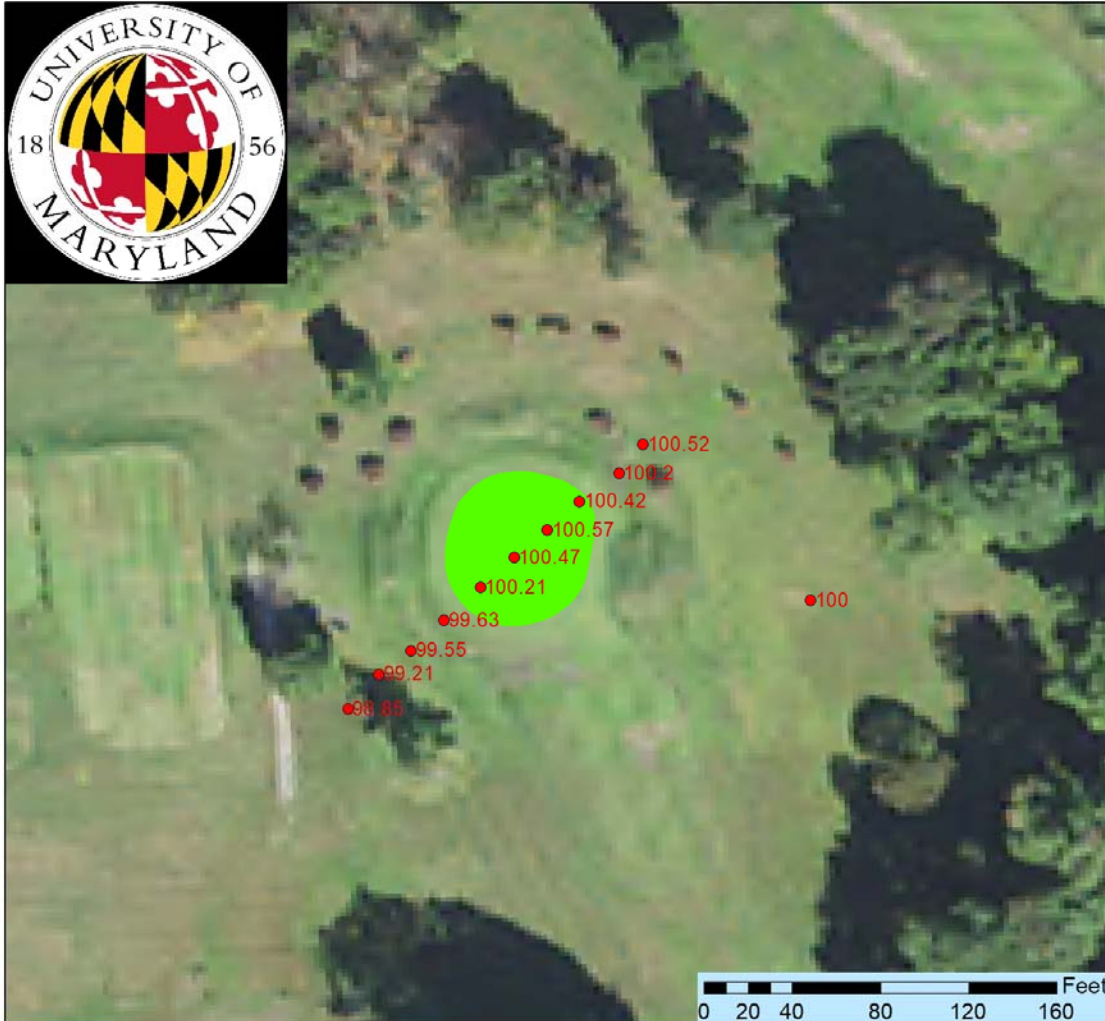
Paint Branch: Number 8 Green

Paint Branch Hole 8 Elevation and Slope				
1	2	3	4	5
				Elev
STA	BS	HI	FS	Profile
BM	4.32			100.00
		104.32		
0+00			3.80	100.52
0+18			4.12	100.20
0+36			3.90	100.42
0+54			3.75	100.57
0+72			3.85	100.47
0+90			4.11	100.21
1+08			4.69	99.63
1+26			4.77	99.55
1+44			5.11	99.21
1+62			5.47	98.85
BM			4.32	
Existing Slope		0.01031	1%
