Small Scale Vapor Mitigation

From Due Diligence to Post System Installation Operations and Maintenance Plans

November 15, 2024

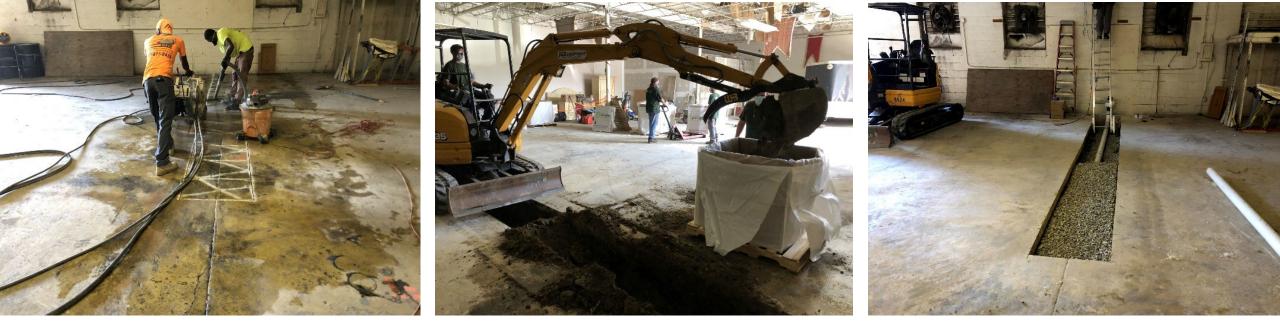
SSDS DESIGN AND INSTALL

Primary System

- 15 ft x 1 ft x 2 ft trench
- 3 inch pvc piping
- FanTech RN2
- Pressure Gauge/Alarms
- Permanent VMPs
- Soil Removal

Secondary System

- Extraction Sump
- 3 inch pvc piping
- FanTech RN2
- Pressure Gauge/Alarms
- Permanent VMPs
- Waste Disposal
