PCE Drycleaner Contamination
Industrial Dry
(The Basics)
Cleaners

Presented by Paul H. Hayden, P.G., L.R.S., R.S.M.

McCord Laundry and Cleaning, Inc. The Beginning

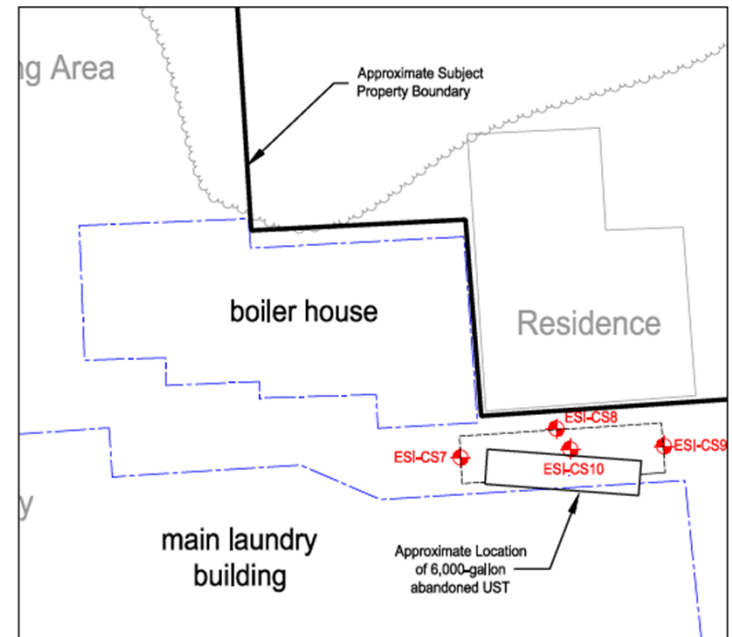
COURTYARD EXCAVATION

UST EXCAVATION

- Identification and approximate location of soil samples collected by GTA ESI on January 7, 8, and 23, 2015.
- Approximate limits of soil excavation activities.

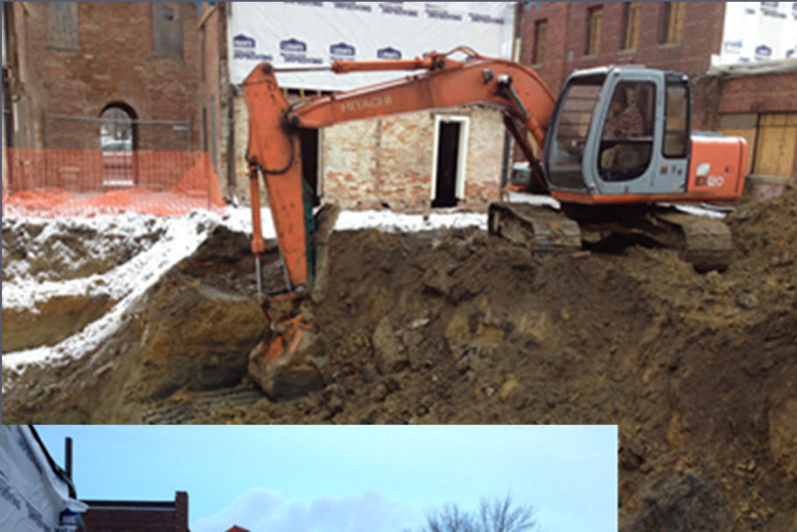
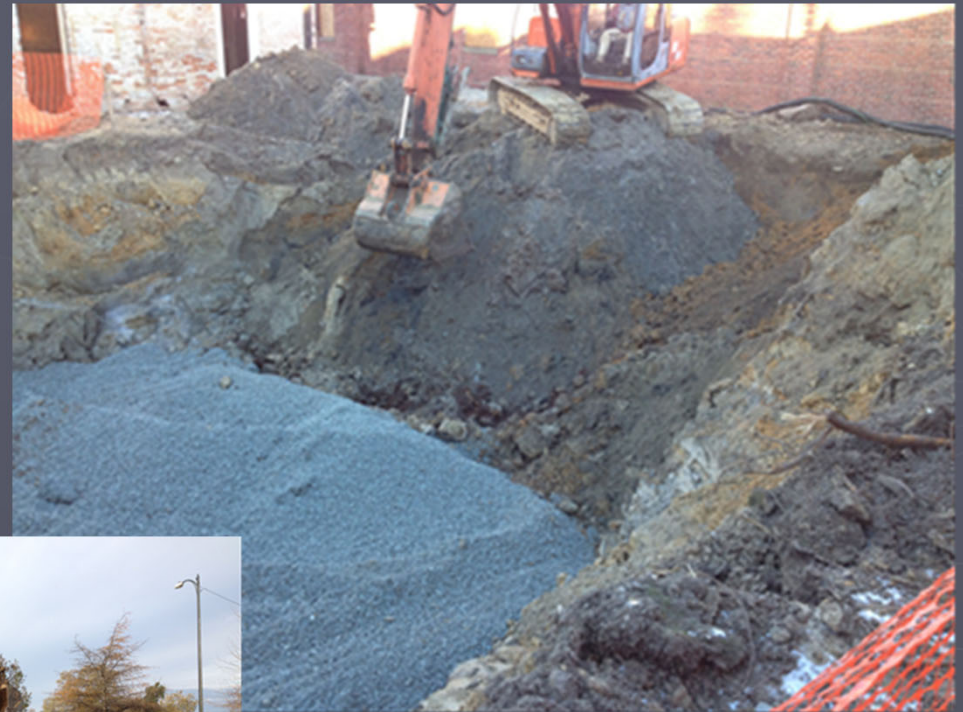
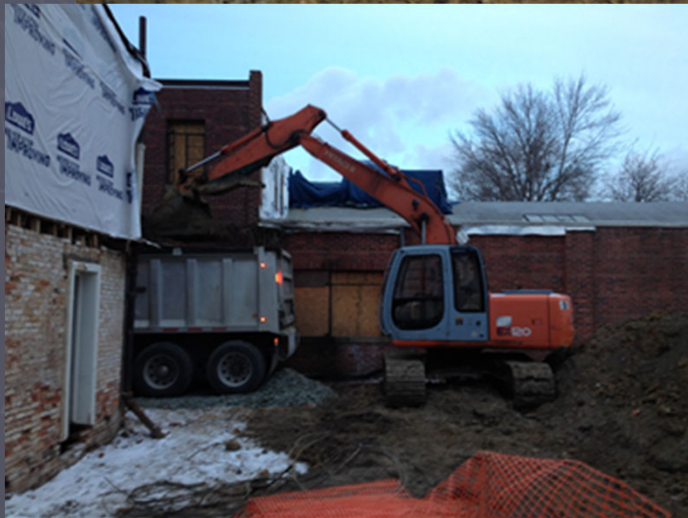
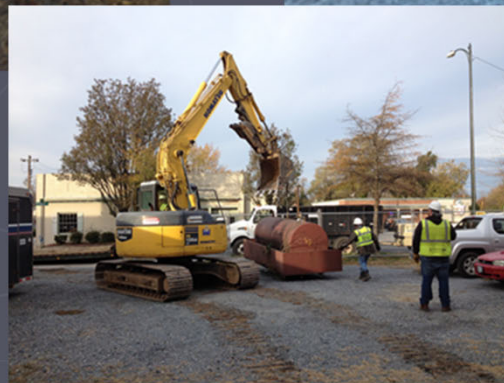
~1,400 tons of impacted soil removed

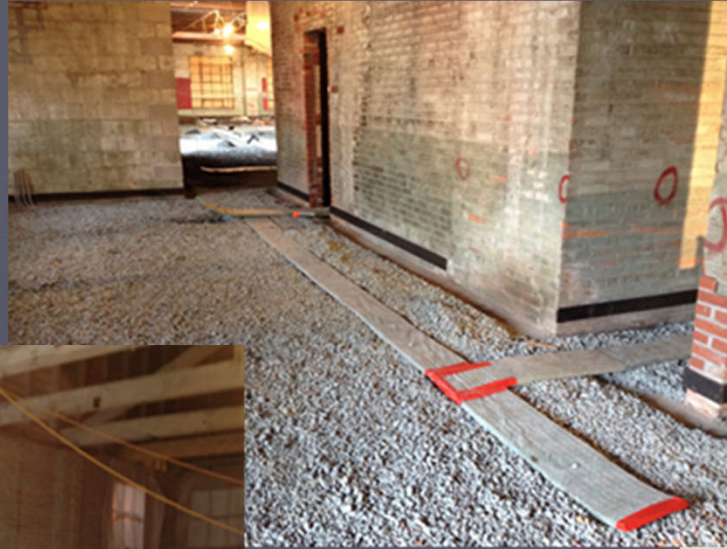
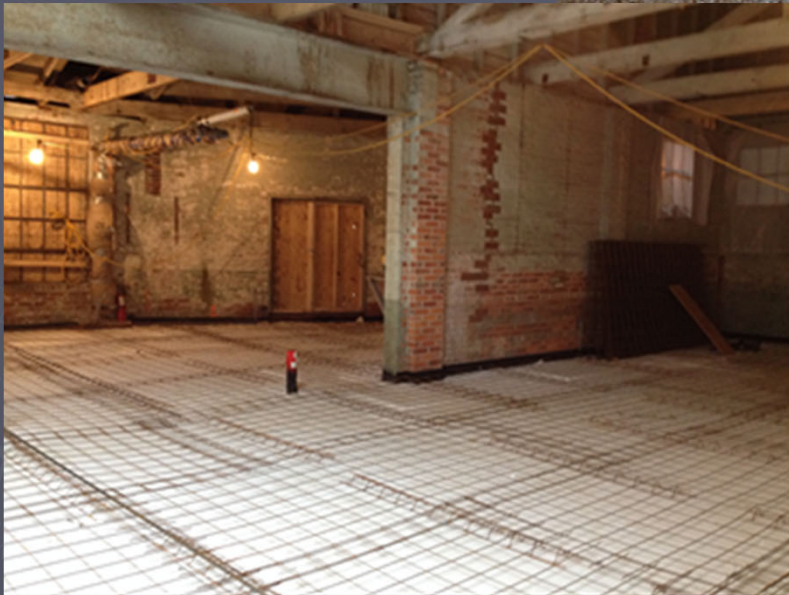
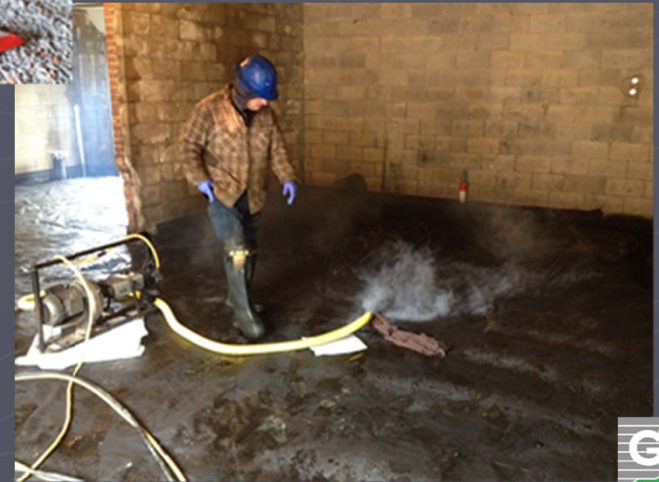
Epro System III MB vapor barrier was installed in each building.

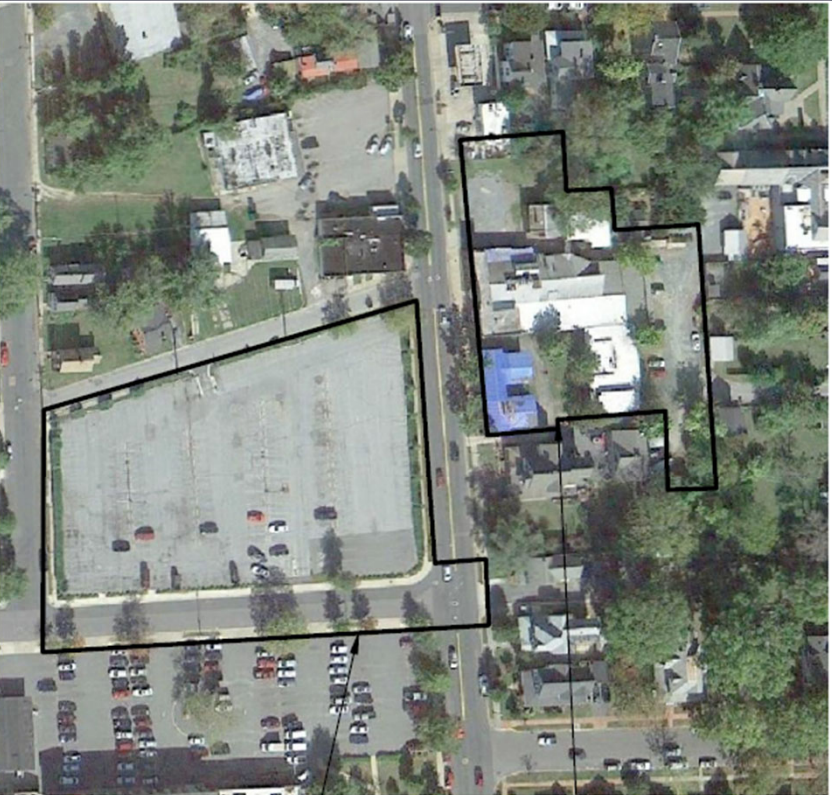
Approximate Location of Off-Site Sampling

Approximate Subject Property Boundary
